GENERAL INFORMATION

Product: **Pulsarlube M 125cc/PL1**
 Industry: Energy (Public)
 Customer: **KDHC (Korea District Heating Corporation)**
 Application: **Cooling Tower**
 Installation: January 9, 2012

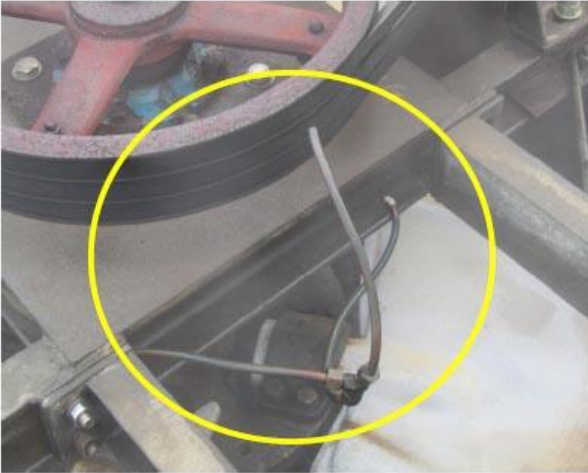
On the top area of the cooling tower, there is a T-valve installed to lubricate both top and bottom bearing via copper tube. We observed that the lube line is gone (found the signs of fracture) and no lubrication has been applied at all.

T-valve with broken lube line

T-valve is dismantled and two units of the Pulsarlube M 125cc filled with PL1 installed on the top area of the cooling tower. New copper tube has also replaced old broken lube line for remote installation. Refer to following information.

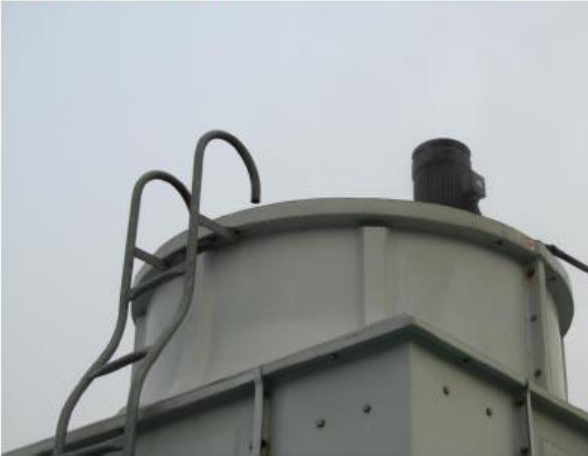
No lubrication device

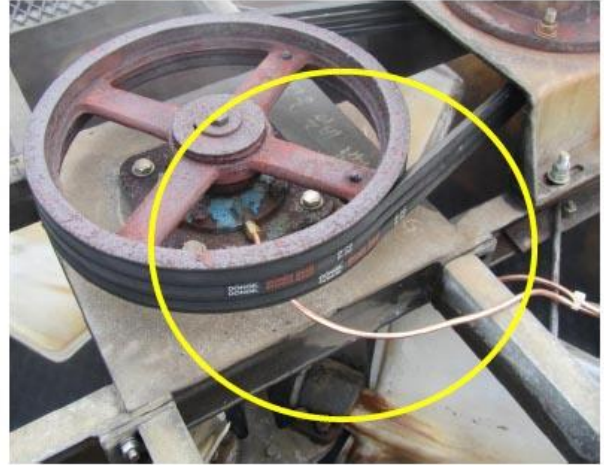
New lube line without T-valve

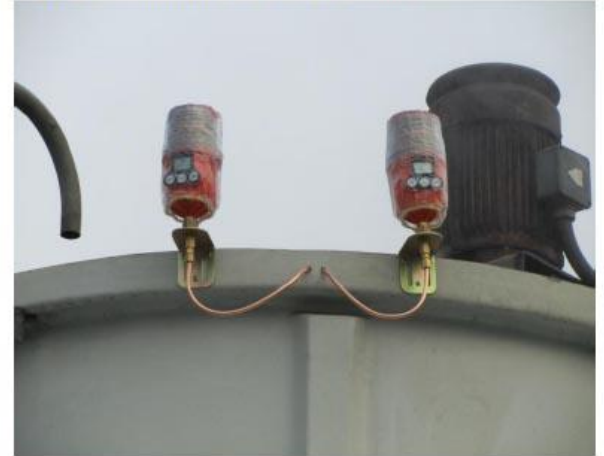
Two Pulsarlube M 125 units installed
